Pre-Purchase Standard Property & Timber Pest Report

20 Parkham Street, Wavell Heights, Queensland

13 May 2022

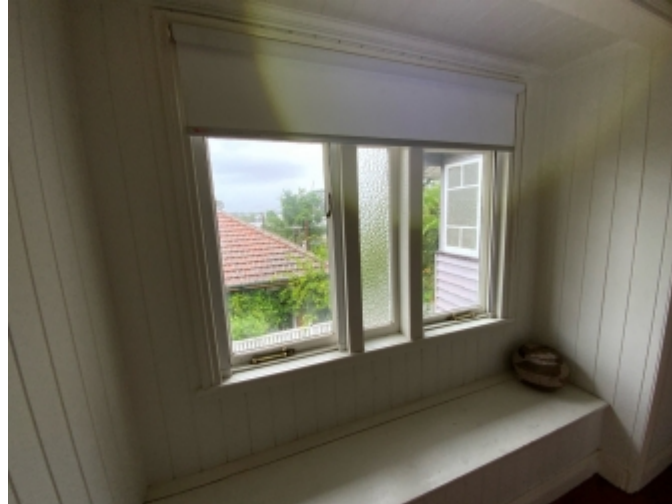
Upper level windows with no fall prevention, recommend a builder to rectify to reduce the risk of people falling out of the windows

Showing upper level windows with no fall prevention

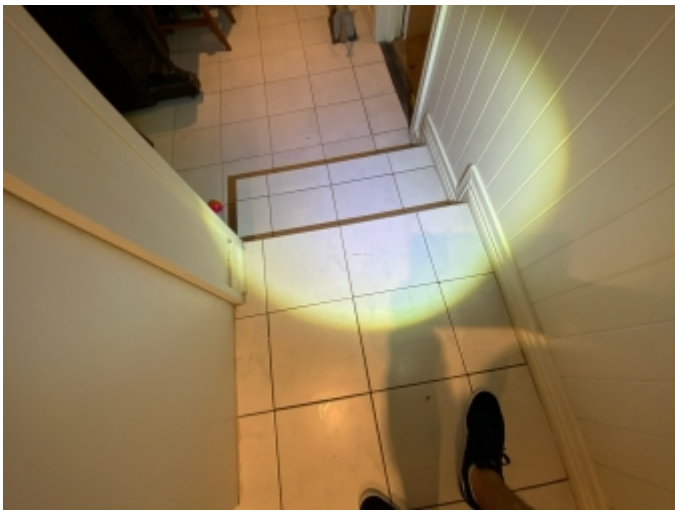
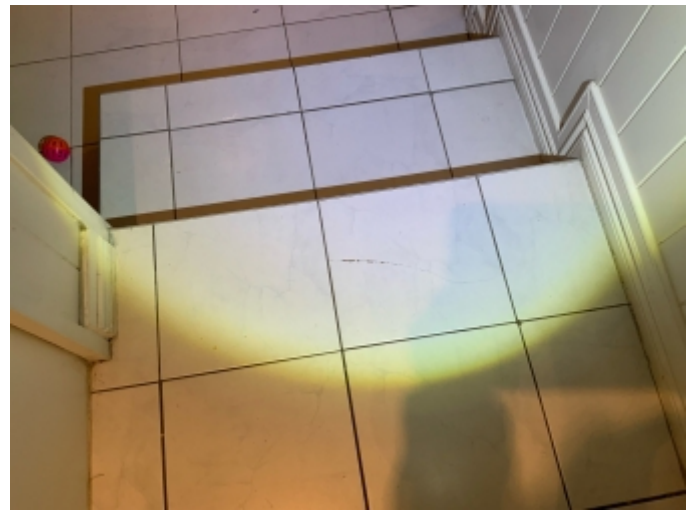
Laundry floor

Cracked, drummy and/or loose tiles to parts. Recommend a tiler to rectify to reduce the risk of further deterioration.

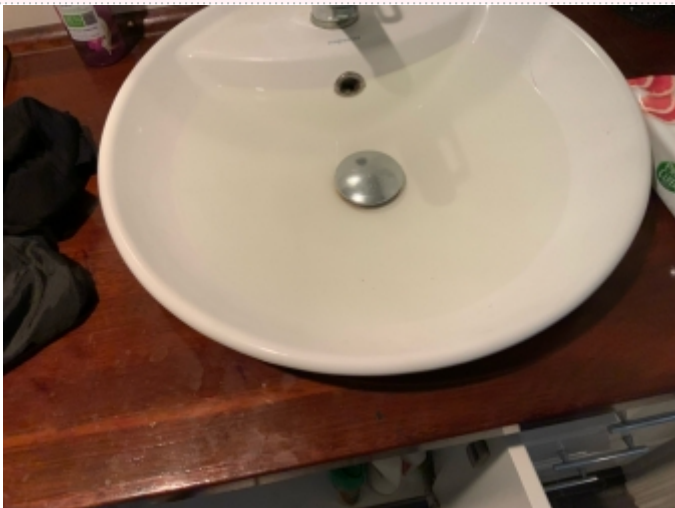
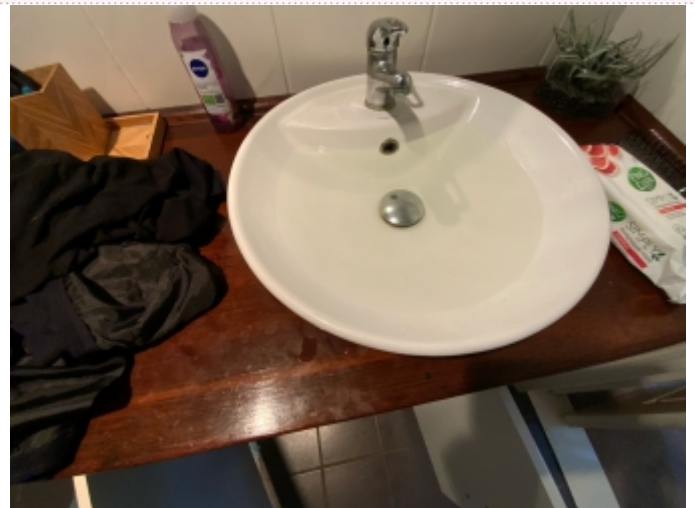
The bathroom vanity basin appears to be not draining properly. Recommend engaging a plumber to rectify to reduce the risk of further deterioration. Recommend undertaking the above as soon as practical.

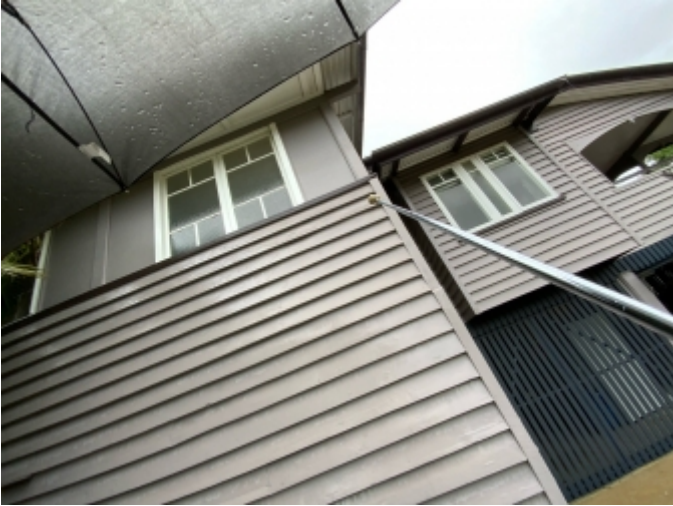
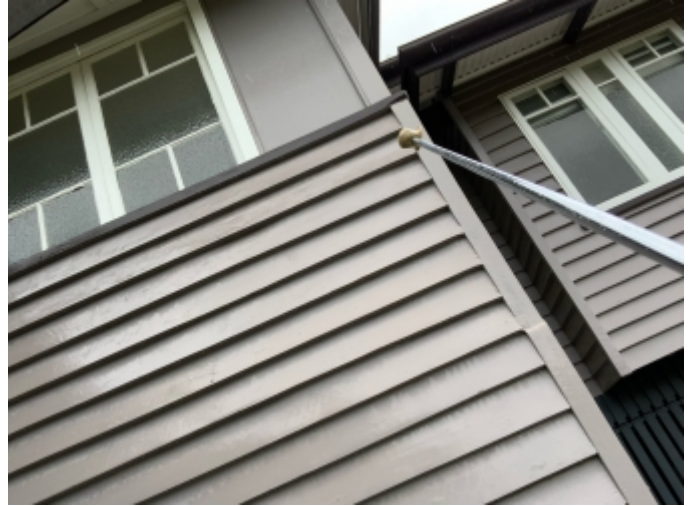
Weathered timbers to parts. Recommend a carpenter to repair/replace as required to prevent further deterioration. Ensure all exposed timbers are painted to maximise the life of the timbers.

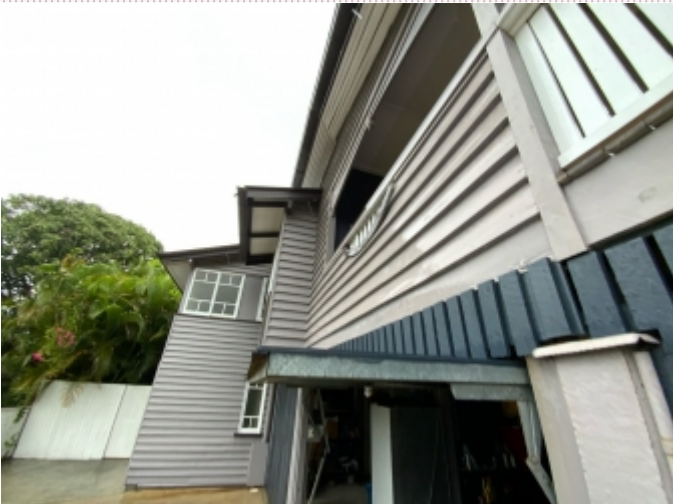
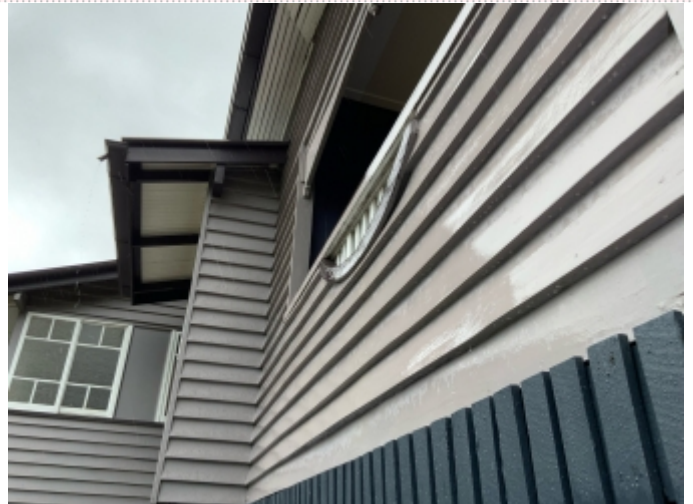
Weathered timbers to parts. Recommend a carpenter to repair/replace as required to prevent further deterioration. Ensure all exposed timbers are painted to maximise the life of the timbers.

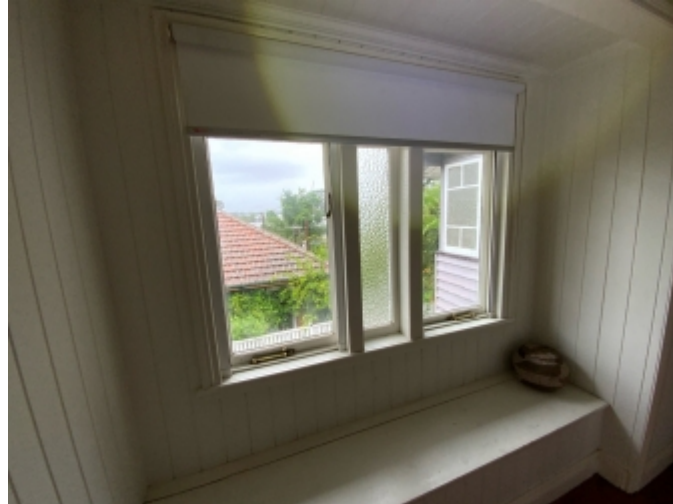
No fall prevention to upper level windows. Windows that are below 1.7m from the inside floor height, and that have a fall height of 2m or more from the inside floor height, should have security screens fitted or be made to open a maximum of 125mm. Recommend a builder to rectify to reduce the risk of people falling out of the window.

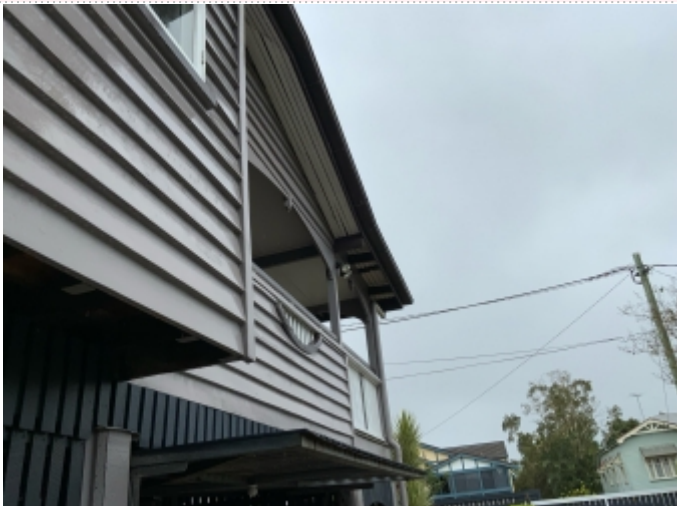
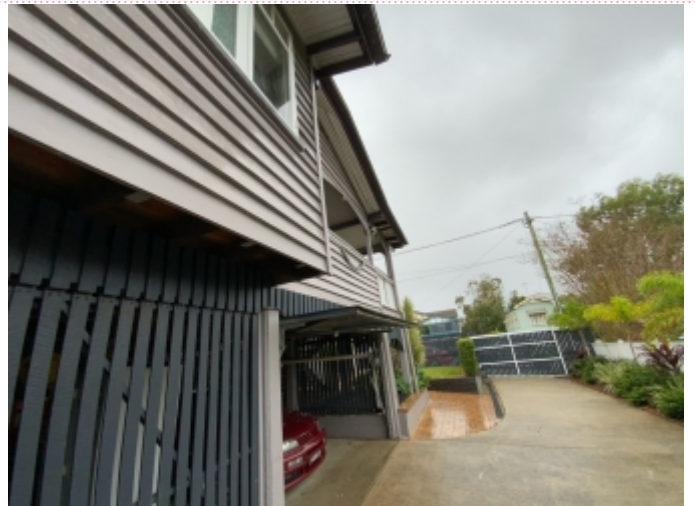
Missed downpipe to the gutter. There is a hole on gutter for downpipe installation. Recommend engaging a plumber to install a downpipe to avoid the risk of footing movement and other moisture related issues.

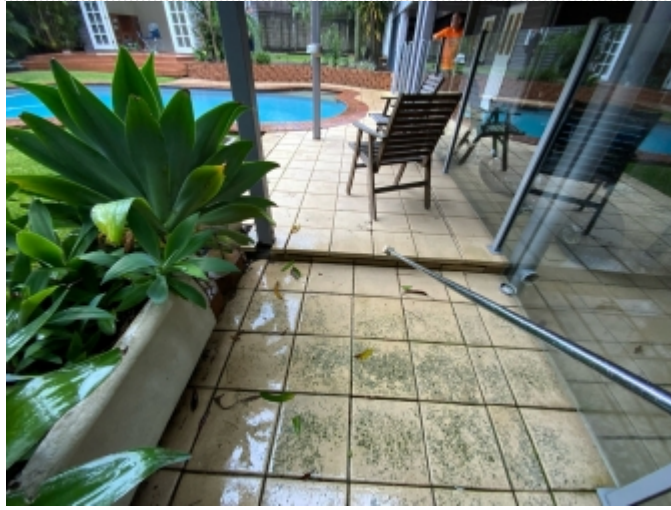
Unevenness and settling to parts of the pavers. Recommend a landscaper to repair/replace as required to prevent personal injury and prevent further deterioration.

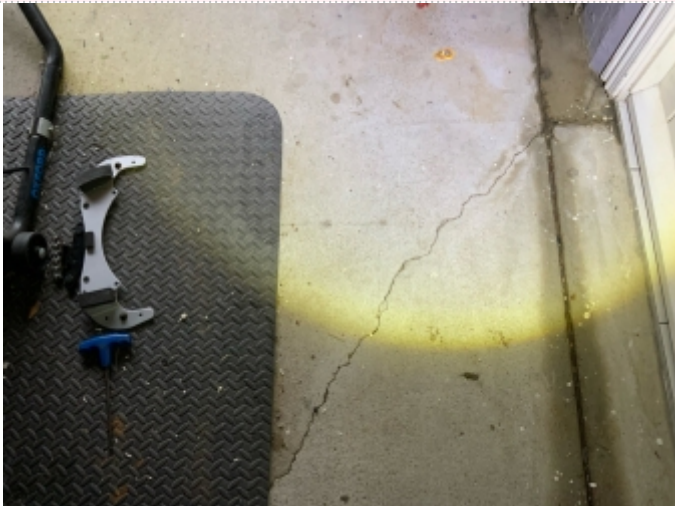
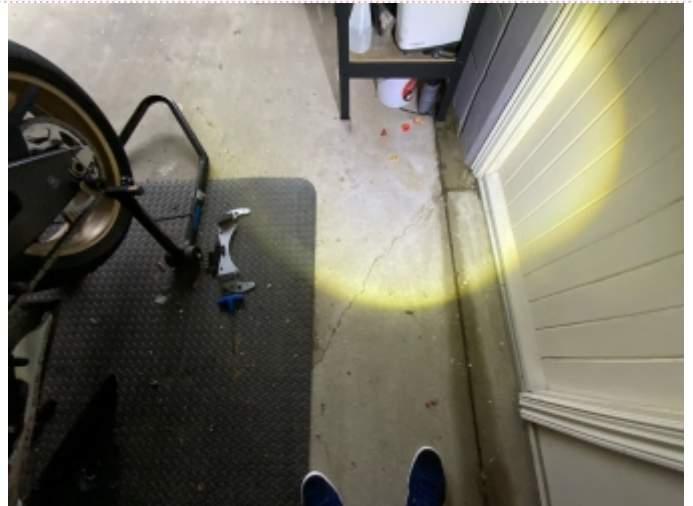
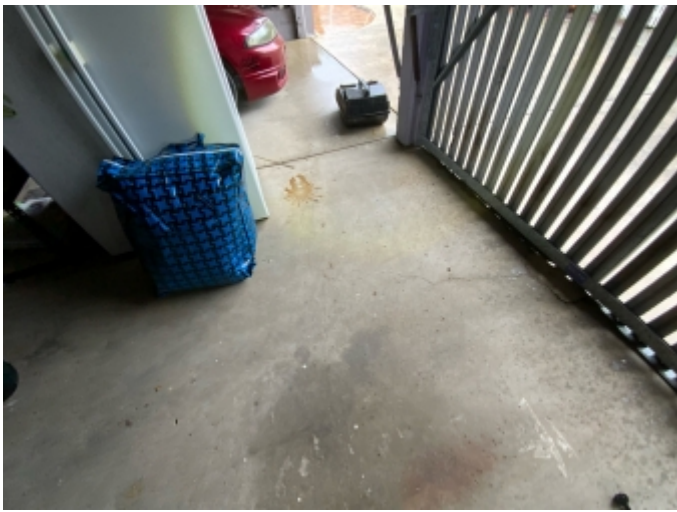
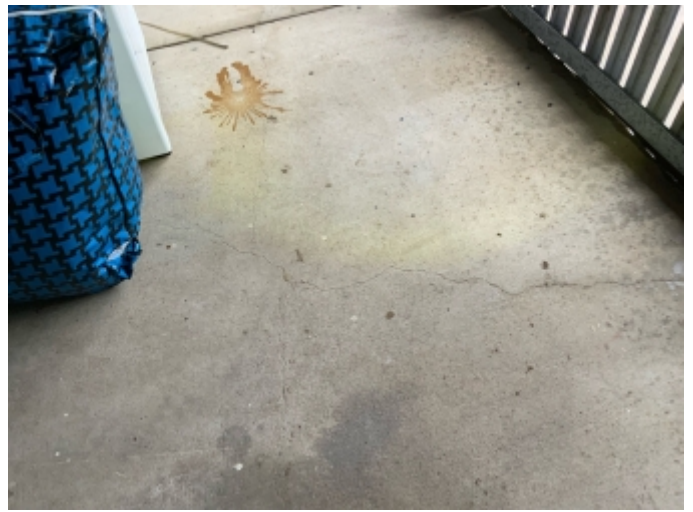
Cracked and uneven concrete. Needs repair/replacing to prevent further deterioration.

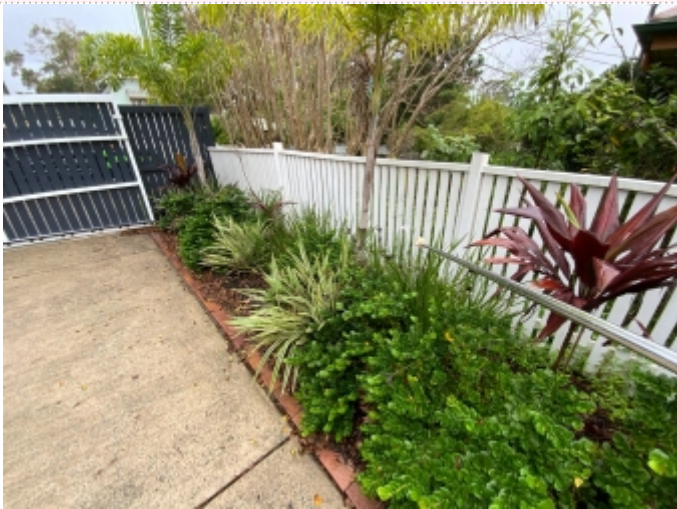
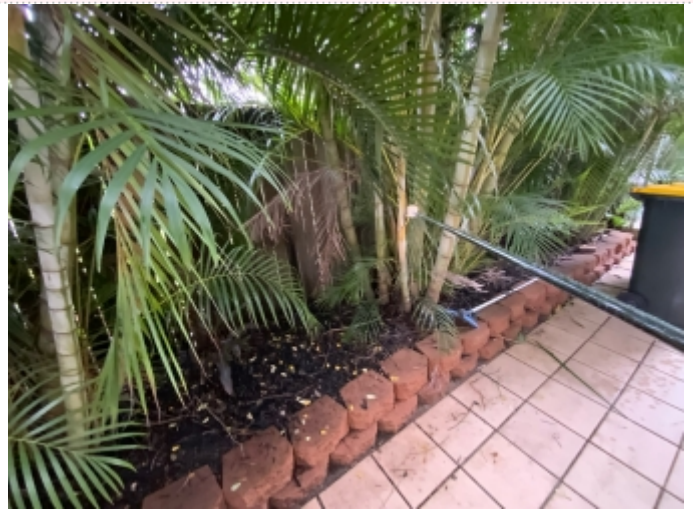
Timber fence has contacted with soil

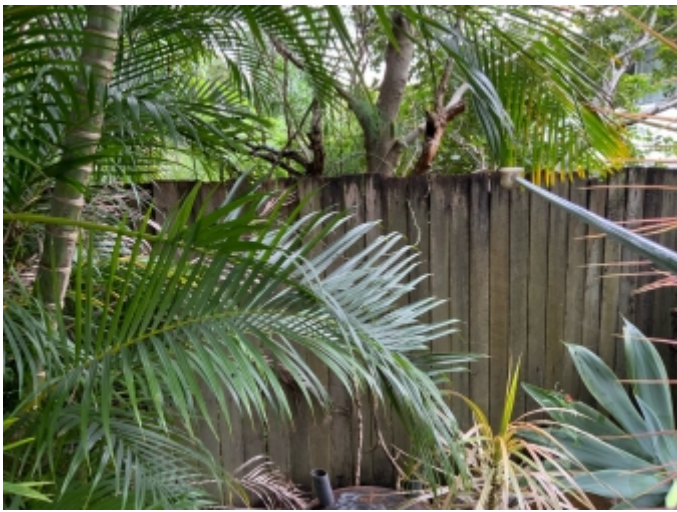
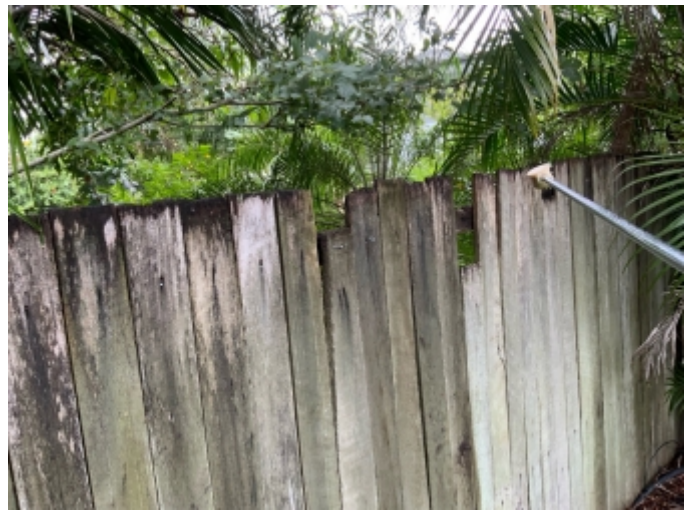
Wood rot/fungal decay to fence - to avoid further deterioration recommend engaging a fencing contractor to repair/replace

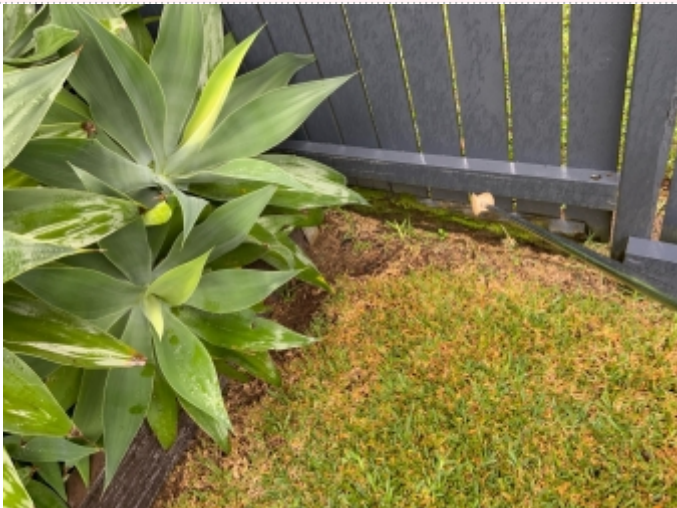
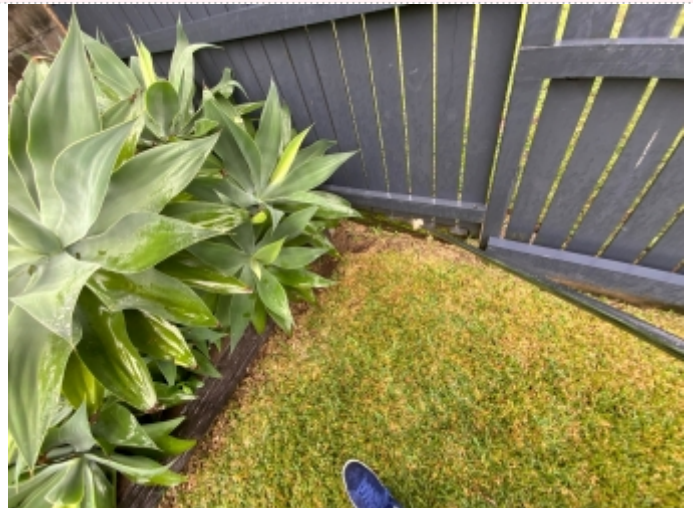
Garden bed

Wood rot to parts of the retaining walls. Recommend engaging a landscaper to repair/replace as required to prevent further deterioration.

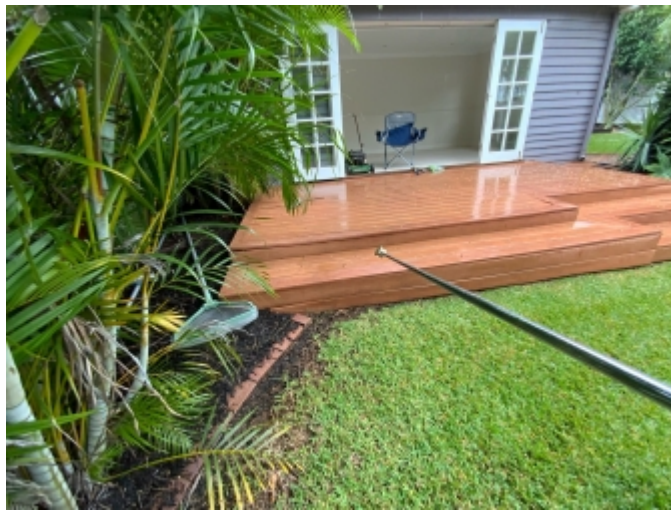
Timbers in contact with the ground to parts. Recommend exposing a minimum of 75mm under all timbers to reduce the risk of termite attack and wood rot.

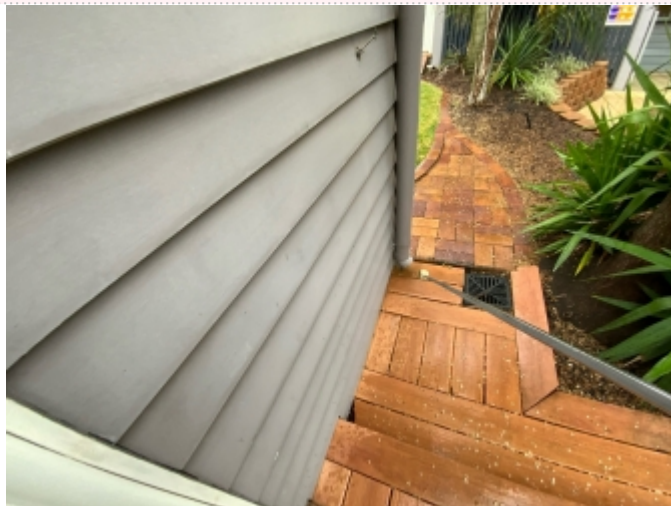
There appears to be downpipes not adequately plumbed into stormwater. The disposal of water around the structure may increase the likelihood of termite attack and structural damage. Recommend engaging a plumber to rectify as soon as practical, granny flat.

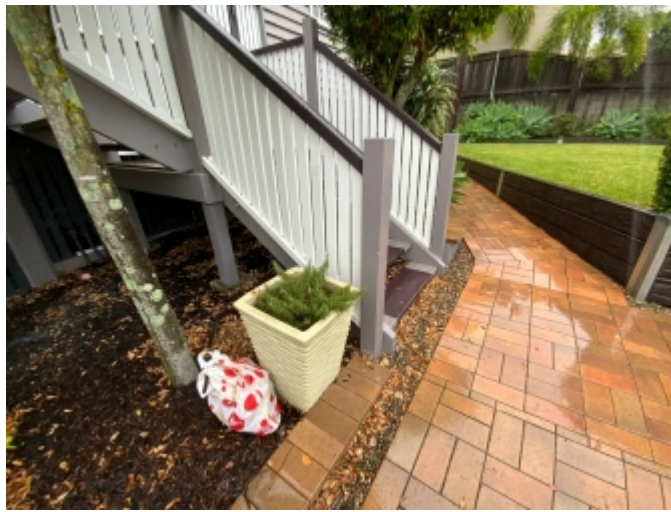
Timbers in contact with the ground to parts. Recommend exposing a minimum of 75mm under all timbers to reduce the risk of termite attack and wood rot.

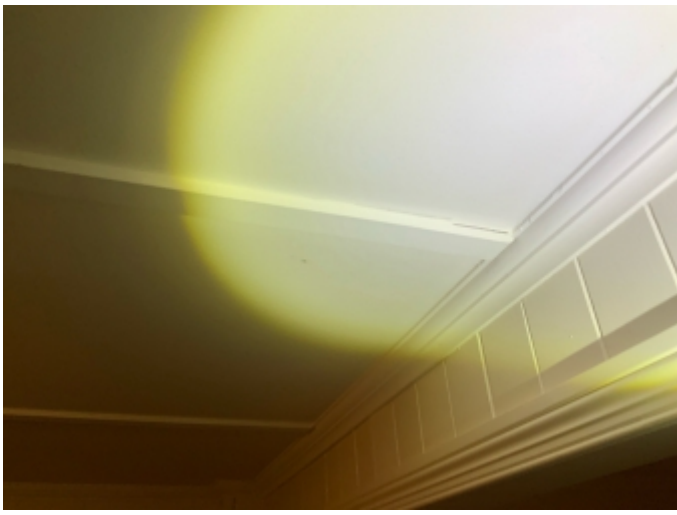
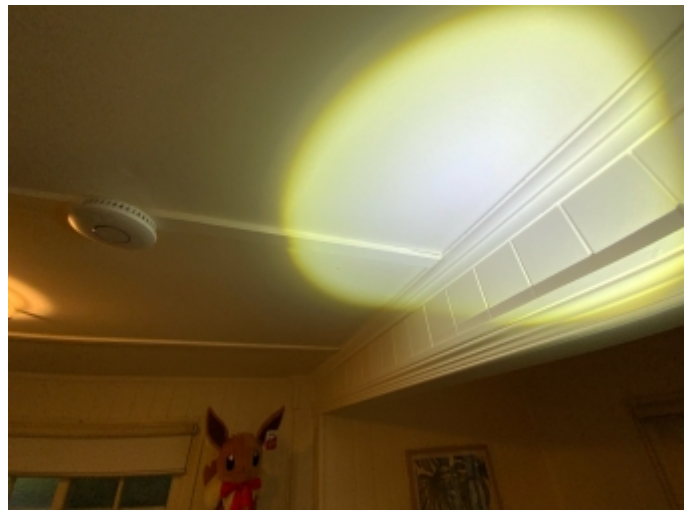
Showing example of settlement crack

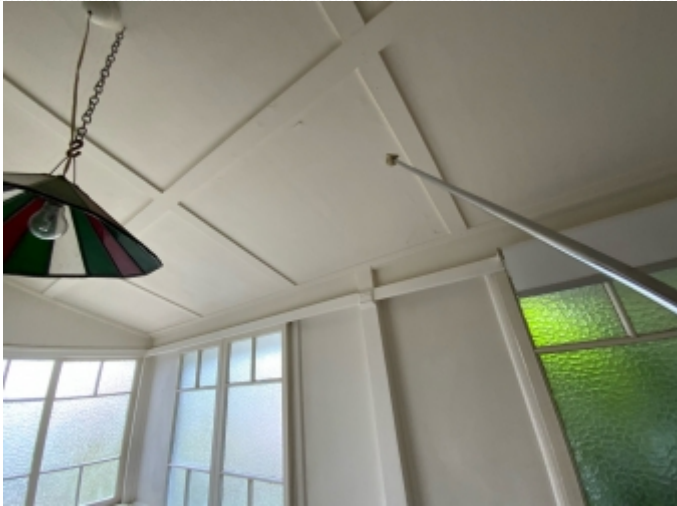
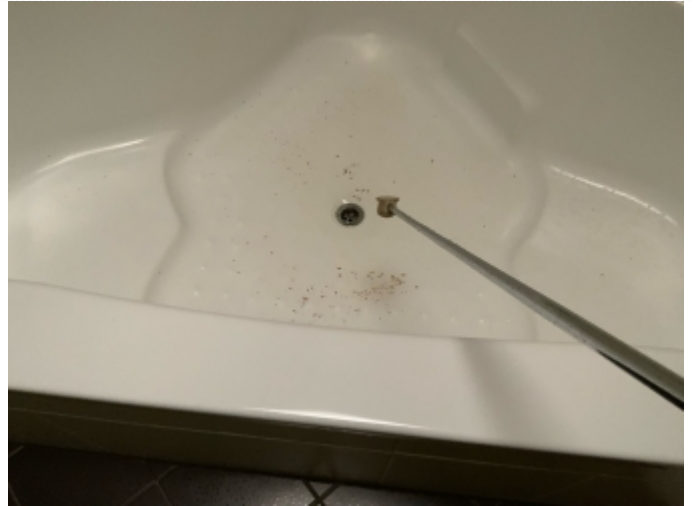
Showing example of cosmetic defect

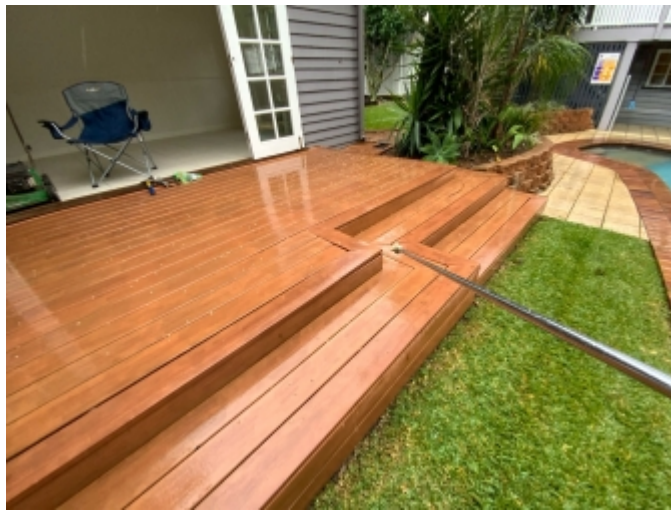
Showing example of minor damage

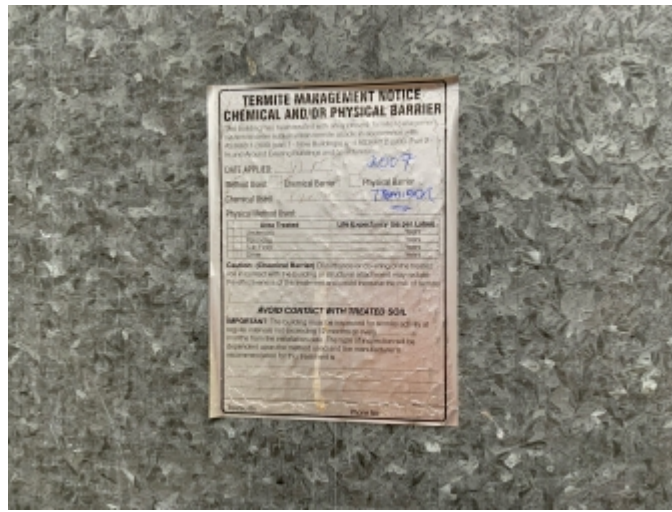
Photo Comments	Showing sign of termite management system in meter box
E5 Frequency of future inspections: The next inspection to help detect termite attack is recommended in:	Monthly until the installed termite management system is verified to be warranted or a new system is installed
E6 Chemical delignification	No evidence was found
E7 Fungal decay	The following evidence was found:
Location	Wood rot to parts of the fences
The extent of any visible damage appears:	Localised
Additional Comments	<p>Ensure all exposed timbers are painted to maximise the life of the timbers</p> <p>Recommend making all timbers to not be in contact with the ground</p> <p>Recommend replacing all damaged timbers</p>

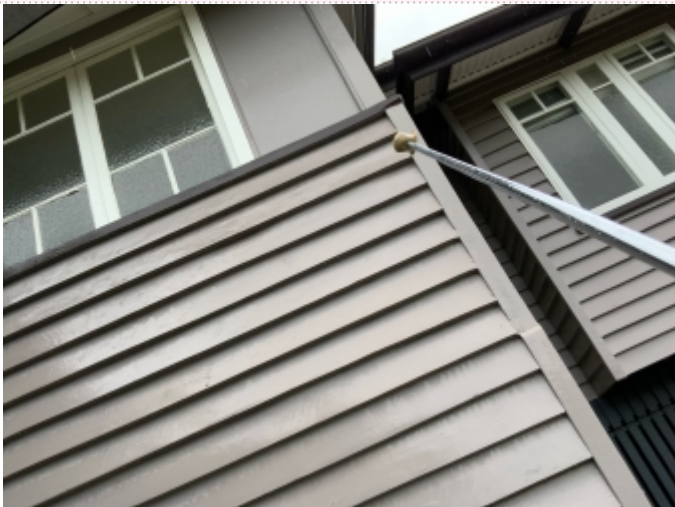
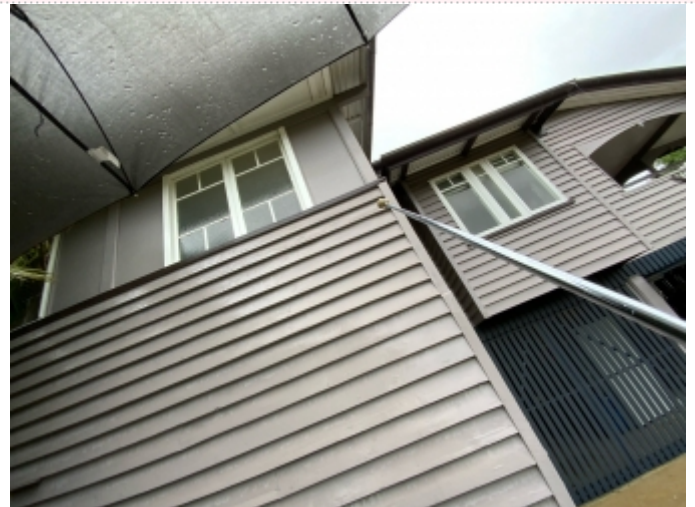
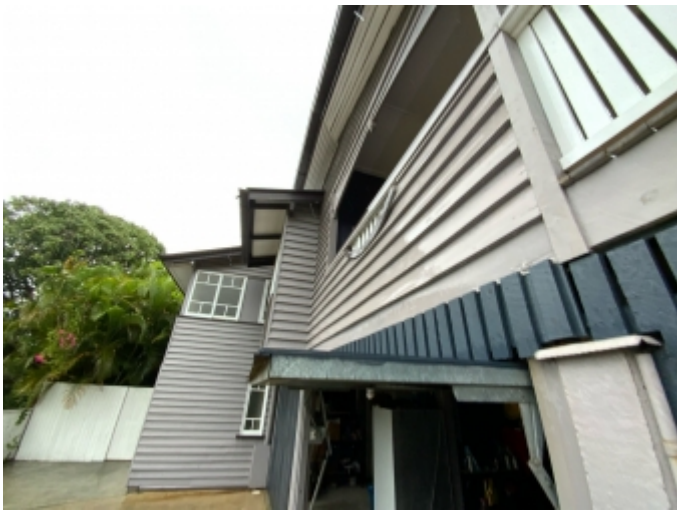
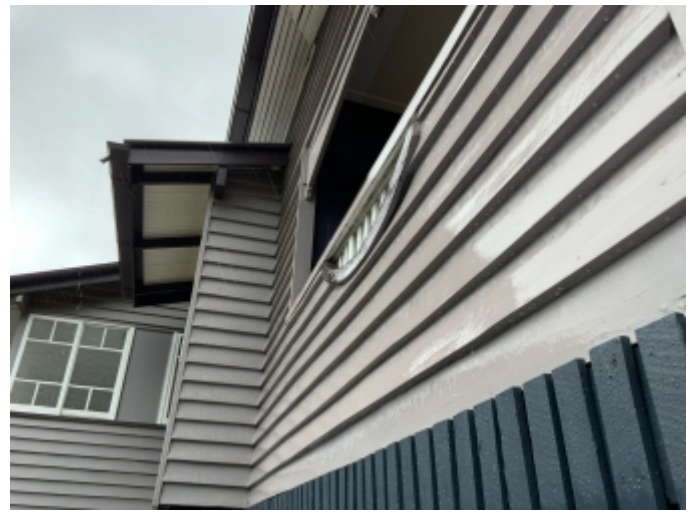
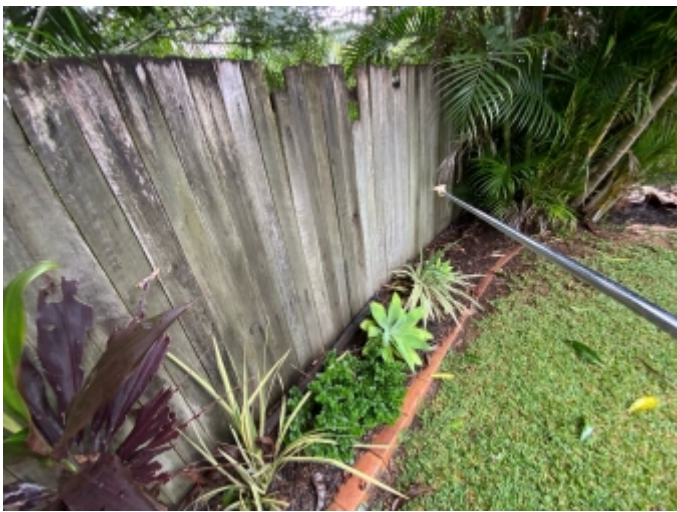
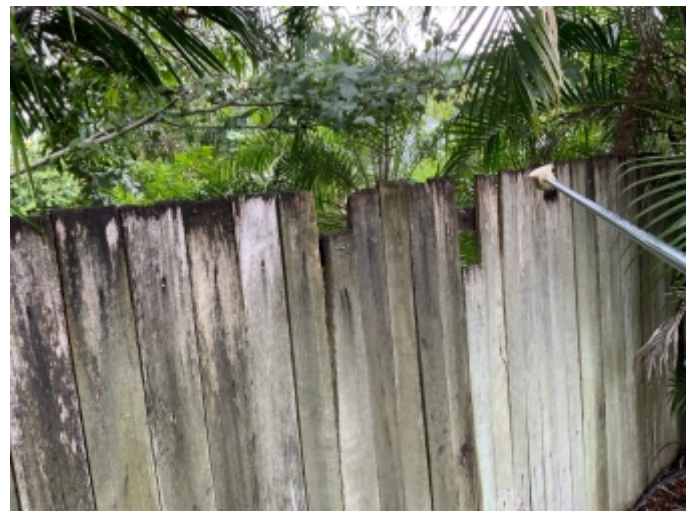
Showing example of wood rot to the timber

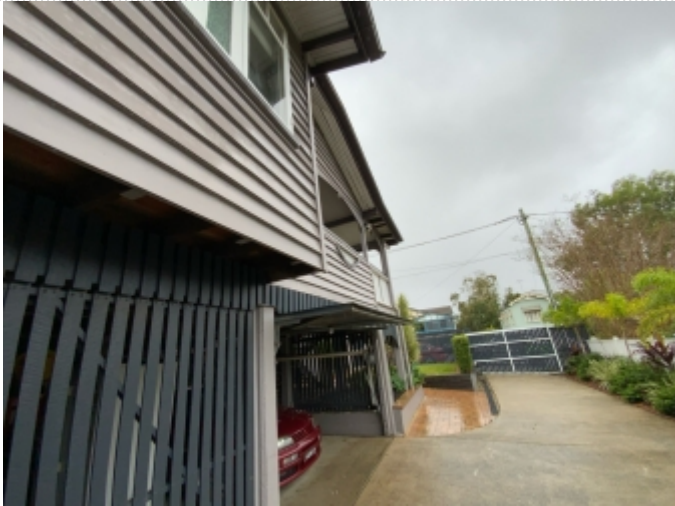
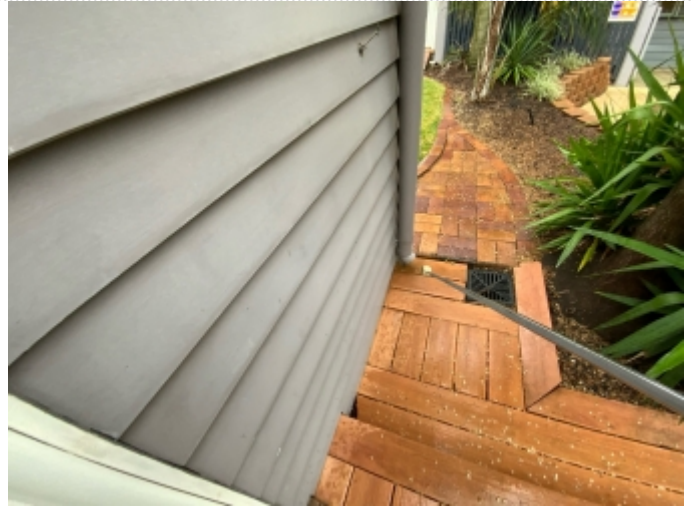
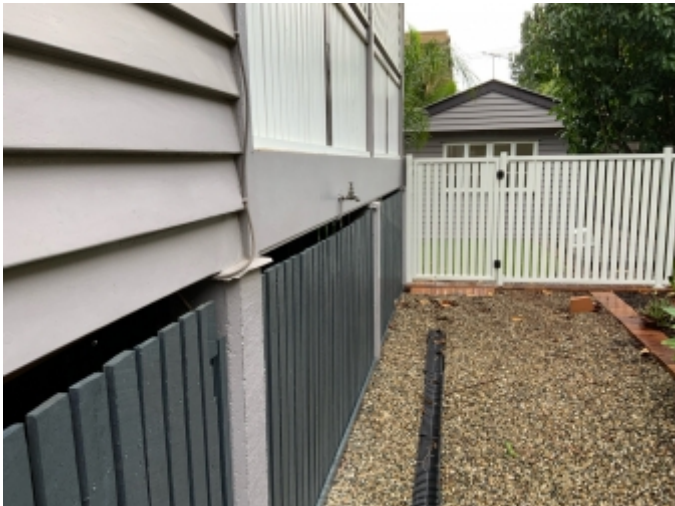
Showing possible source of excessive moisture
