Pre-Purchase Standard Property & Timber Pest Report

20 Parkham Street, Wavell Heights, Queensland

13 May 2022

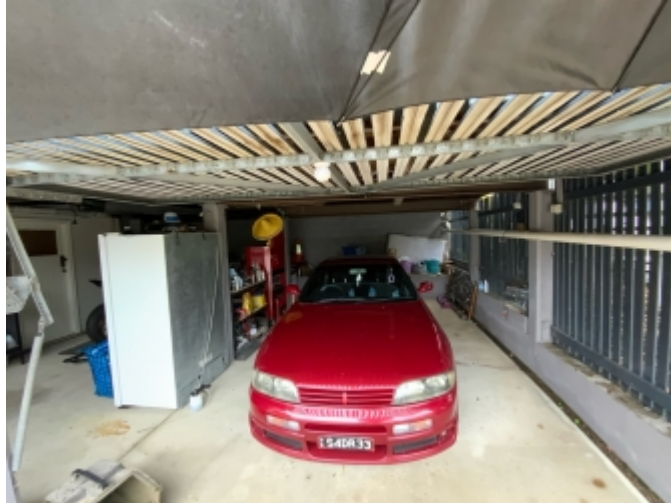
Photo of Obstruction

Showing examples of obstructions throughout the building

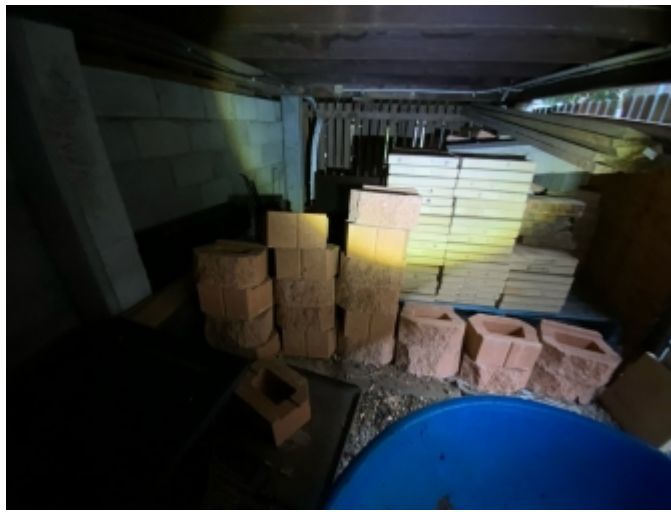
Photo of Obstruction

Showing example of stored items

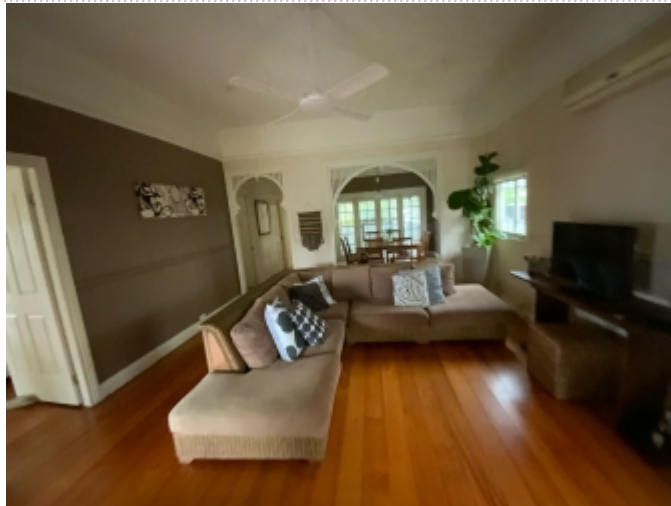
Photo of Obstruction

Showing example of furniture and stored goods throughout the property

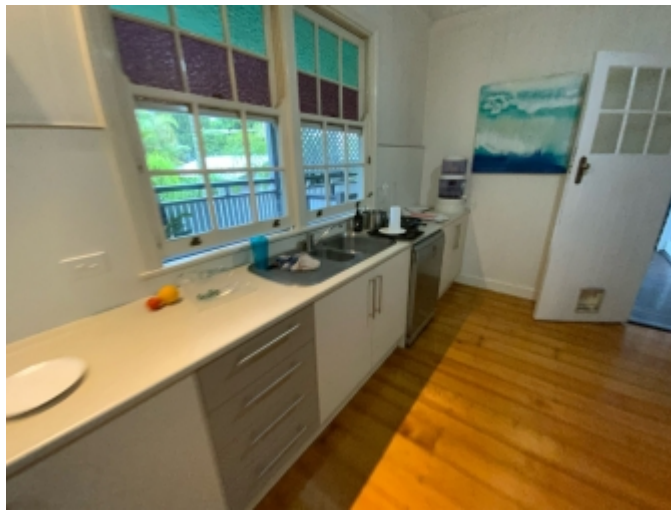
Photo of Obstruction

Showing example of the cabinetry

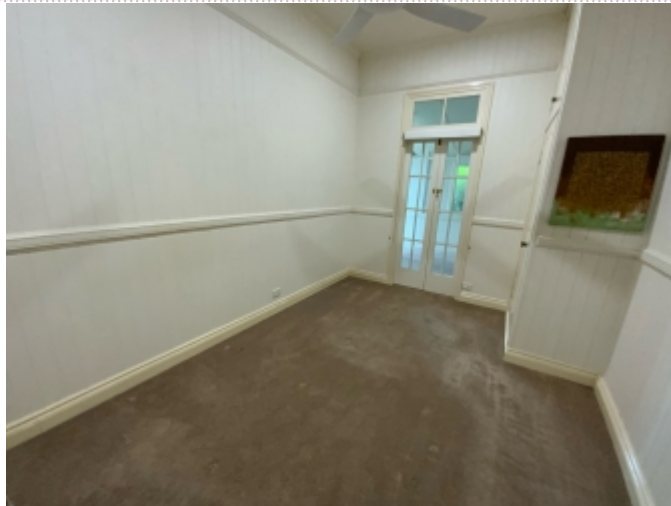
Photo of Obstruction

Showing example of wall, floor and ceiling coverings

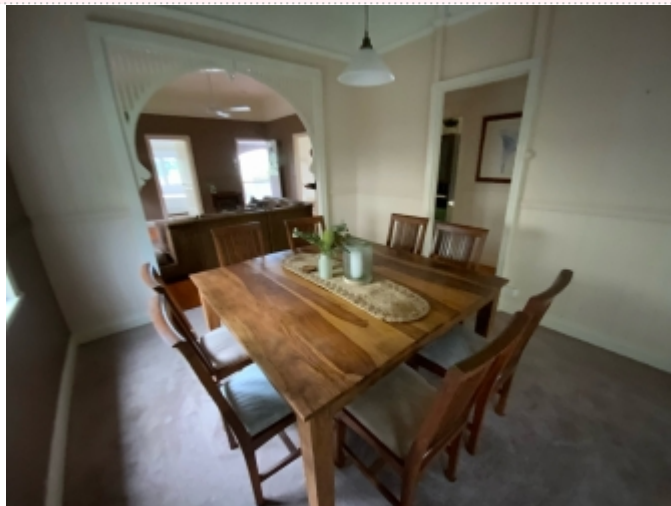
Photo

Showing example of furniture and stored items

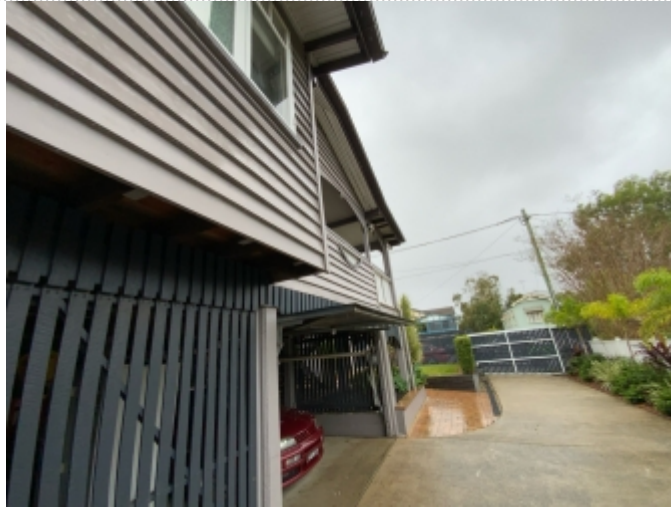
Photo

Showing example of the external walls

And property height

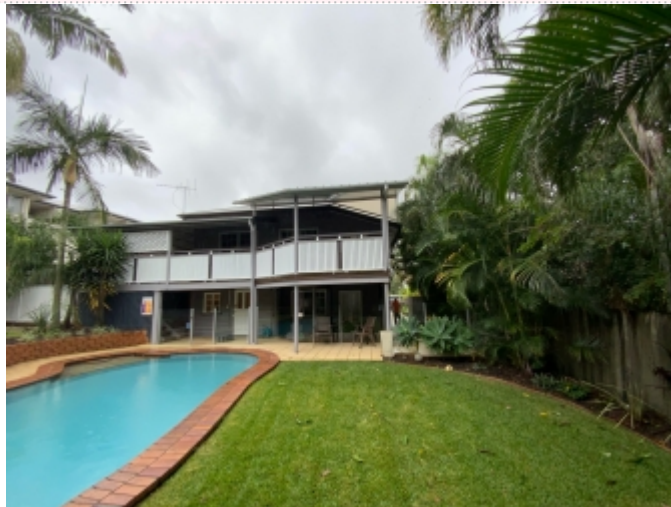
Photo

Showing no access to roof exterior due to height restrictions

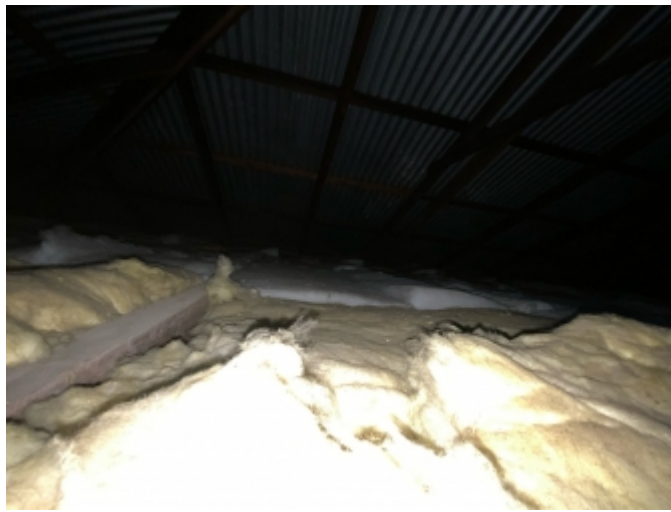
Photo

Showing example of the roof space

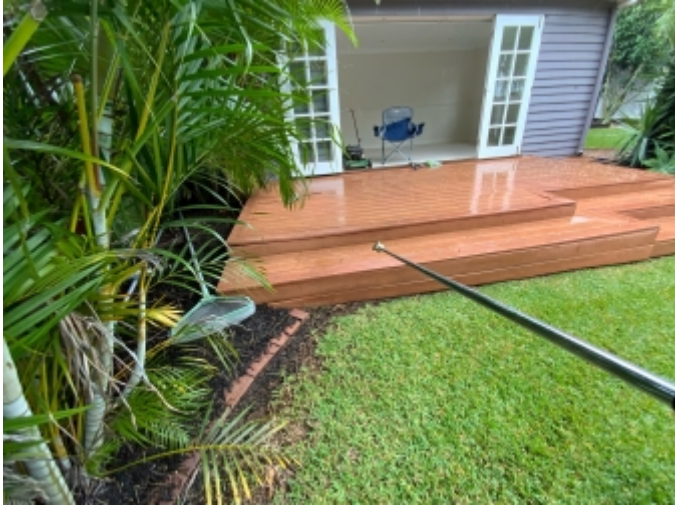
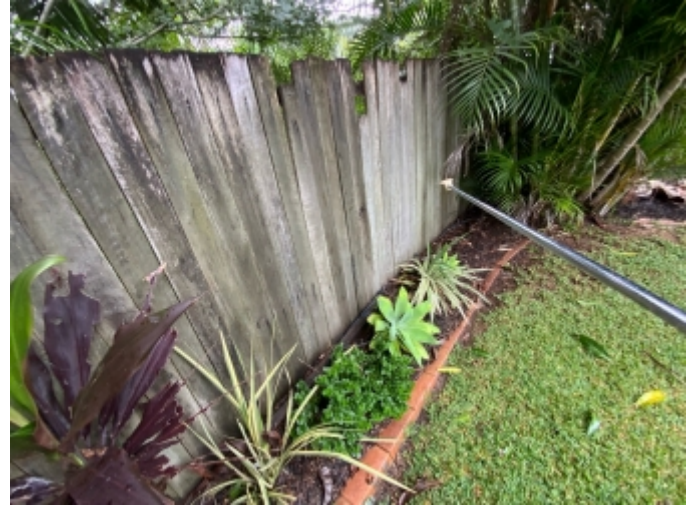
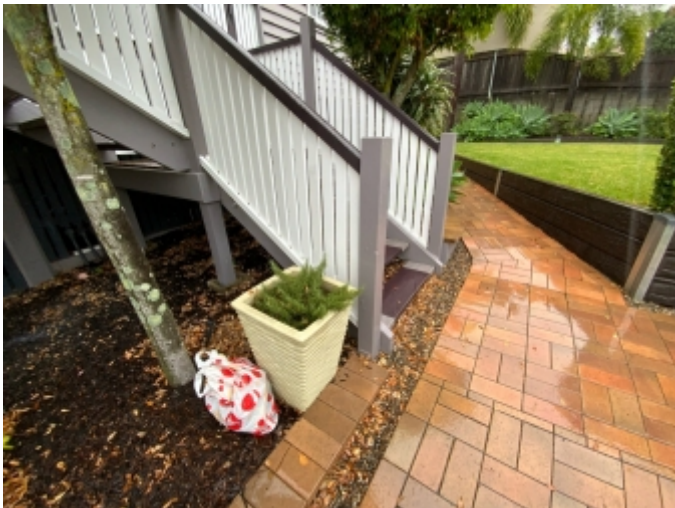
Photo of Bridging

Showing example of bridging/breaching
